<h1>Technical Bulletin</h1>	<b>High End Systems</b>	<b>Page 1/2</b>
	<b>Single Widget Software Compatibility</b>	<b>2-Oct-2015</b>	<b>Rev A</b>

**Single widgets manufactured after September 2015 are compatible only with Hog 4 OS v3.2.1 and above.** If these widgets are "upgraded" via an authorization code using Hog 4 OS PRIOR to v3.2.1, there is a substantial chance the widgets will become unresponsive and require return to High End Systems for reprogramming. To avoid this, upgrade to Hog 4 OS v3.2.1 or above. **DO NOT UPGRADE NEW SINGLE WIDGETS WITH HOG 4 OS PRIOR TO v3.2.1.**

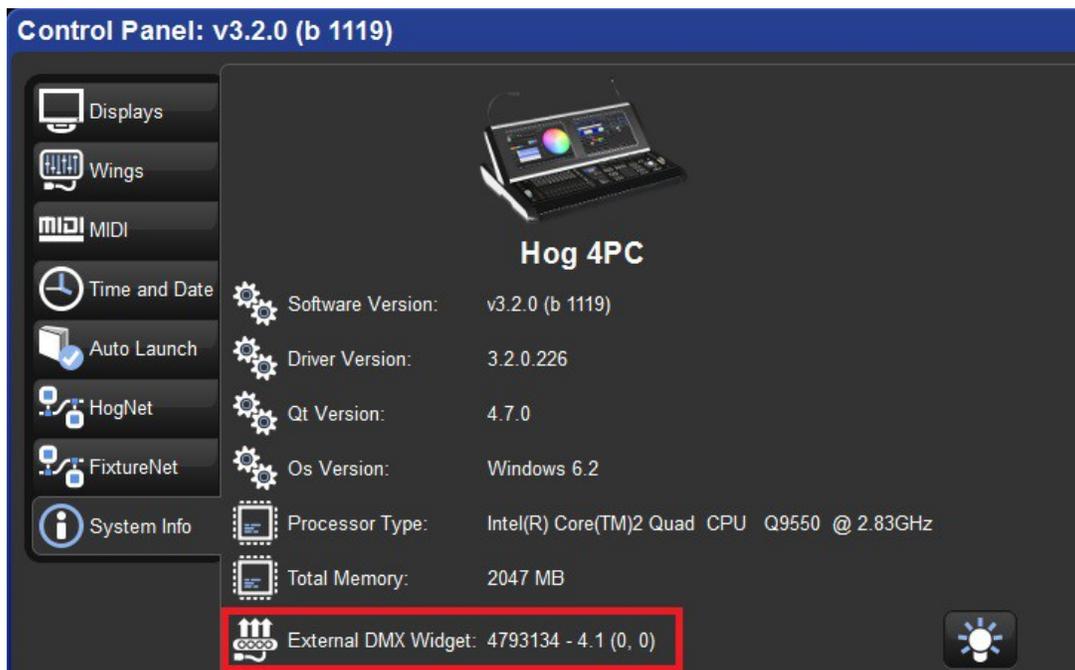
New single widgets are manufactured after September 2015 and have a serial number of 9000 or higher.

When new single widgets are seen by Hog 4 OS PRIOR to v3.2.1, in Control Panel → System Info the serial number will appear incorrect and the firmware version will be 4.1 or higher:

**DO NOT ATTEMPT UPGRADING WIDGETS WITH SERIAL NUMBER 9000 OR ABOVE.**

Instead, customers must **upgrade to Hog 4 OS v3.2.1 or later**. This will recognize the new single widget and allow immediate use of the widget.

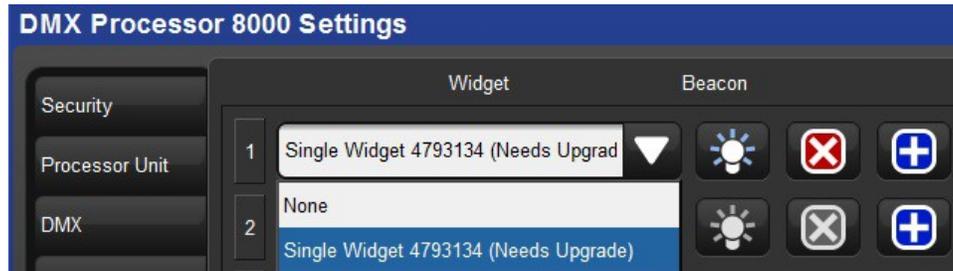
Under Network Settings → DMX Processor 8000 Settings → DMX Widgets, the serial number will appear incorrect, and the widget will indicate "Needs Upgrade":

In addition, the widget will not transmit DMX.
